<b>CATALINA YACHTS</b> 21200 VICTORY BLVD. WOODLAND HILLS, CA		
SCALE: NONE	APPROVED BY:	DRAWN BY <i>SD</i>
DATE: 7/28/85		REVISED 5/20/96
<b>KEEL CRACK REPAIR</b>		
		DRAWING NUMBER

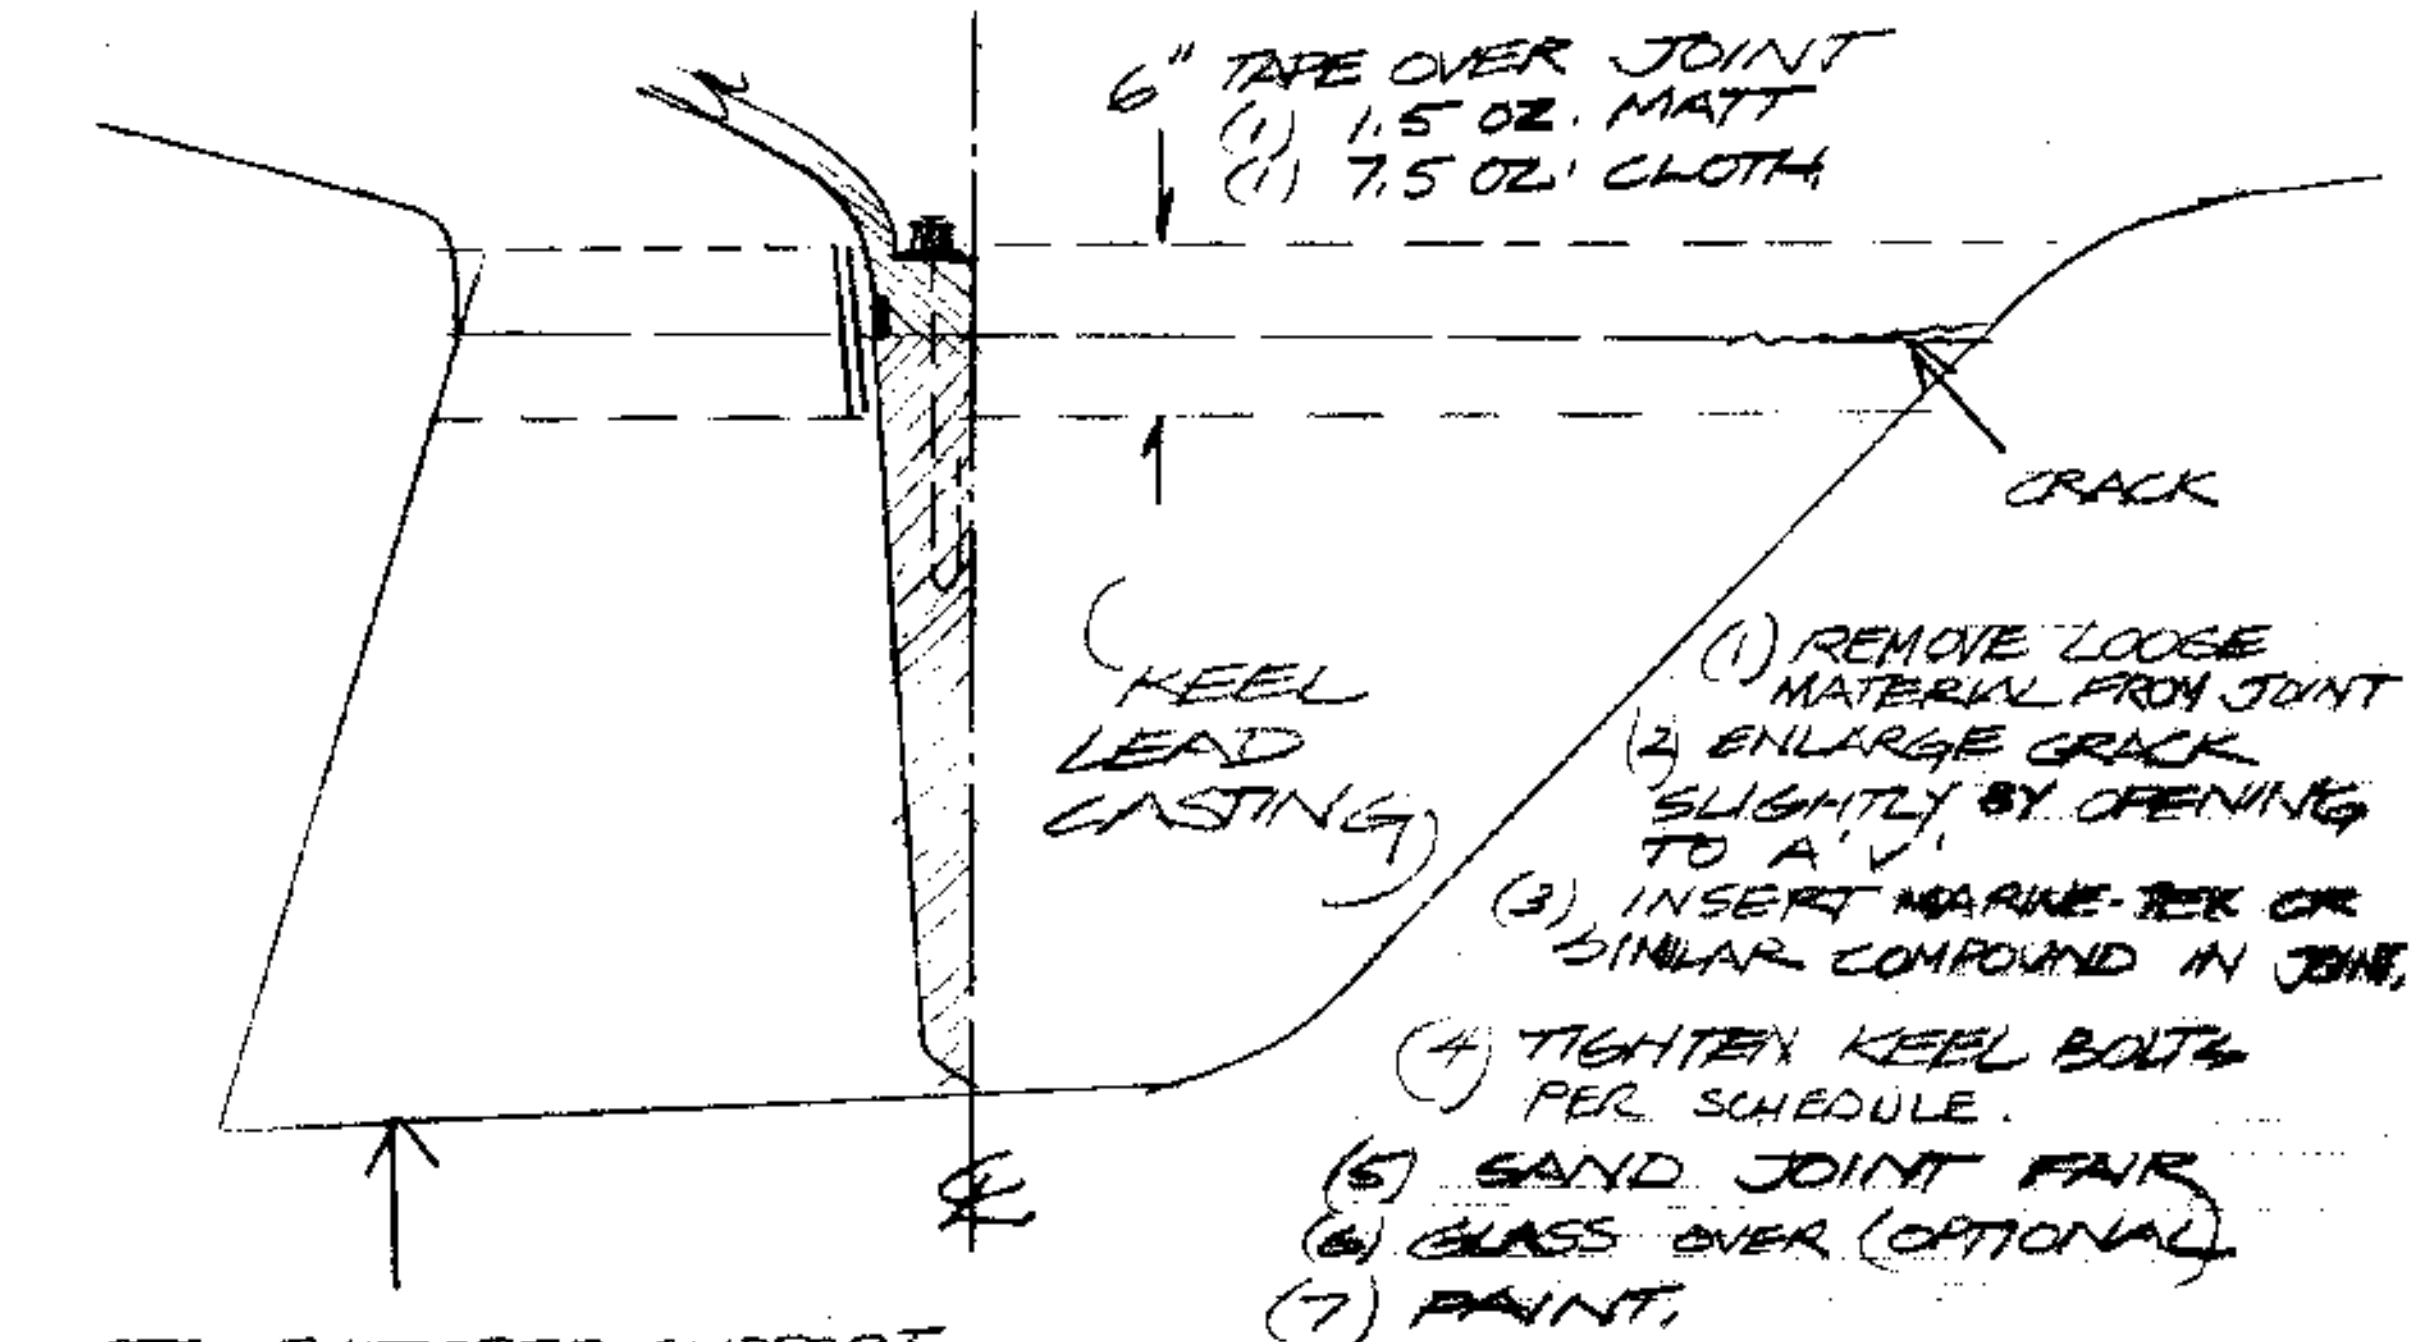
NOTE - IMPROPER SUPPORT OF KEEL FROM AFT END CAN CAUSE FRACTURE OF TAPE BOND AT JOINT AT FRONT OF KEEL
